CERTS MICROGRID LABORATORY TEST BED

Test Plan Section 7.0
Validate Protection Settings and
Initial Fault Testing

Prepared By:
Lawrence Berkeley National Laboratory

SECTION 7.0

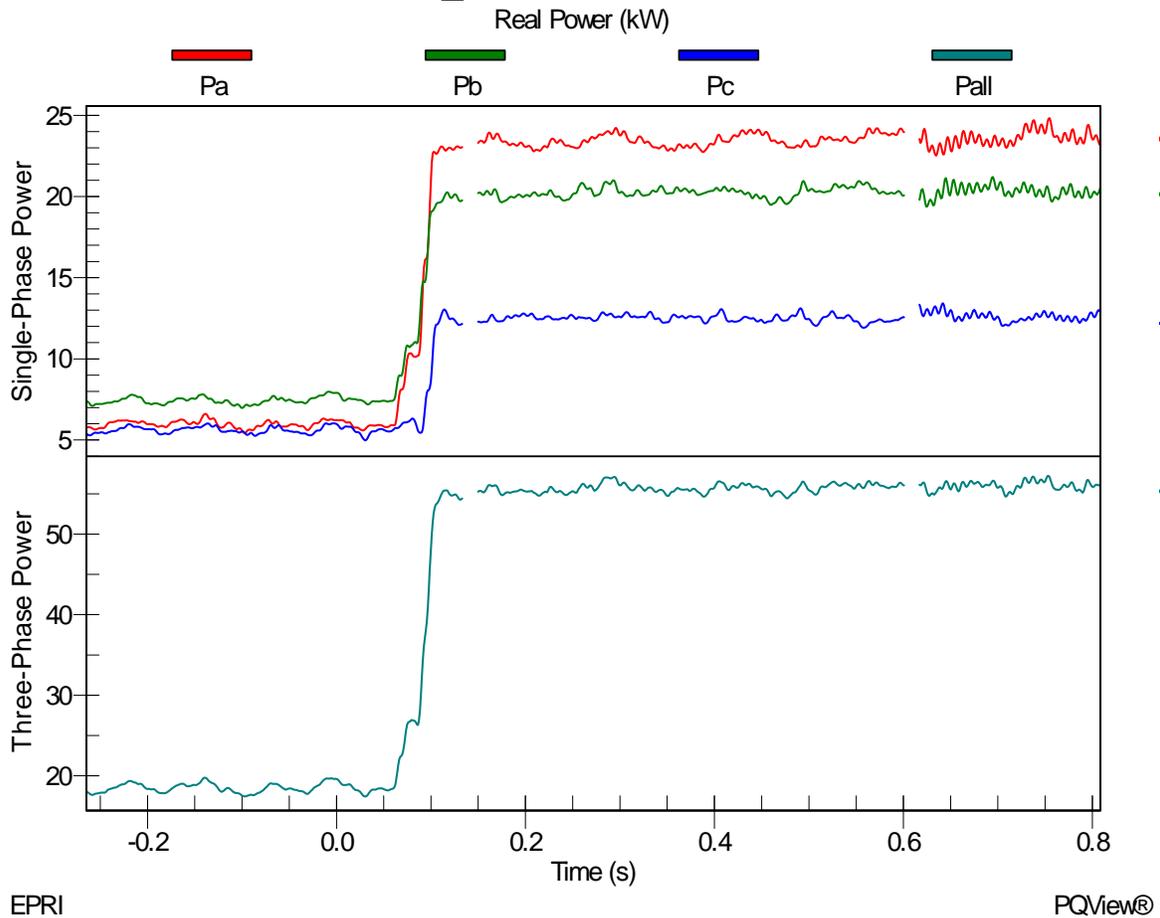
Figure 22d - Power produced by Gen-set A2 before/after the static switch opened when an A-to-B phase fault was applied in Zone 3.

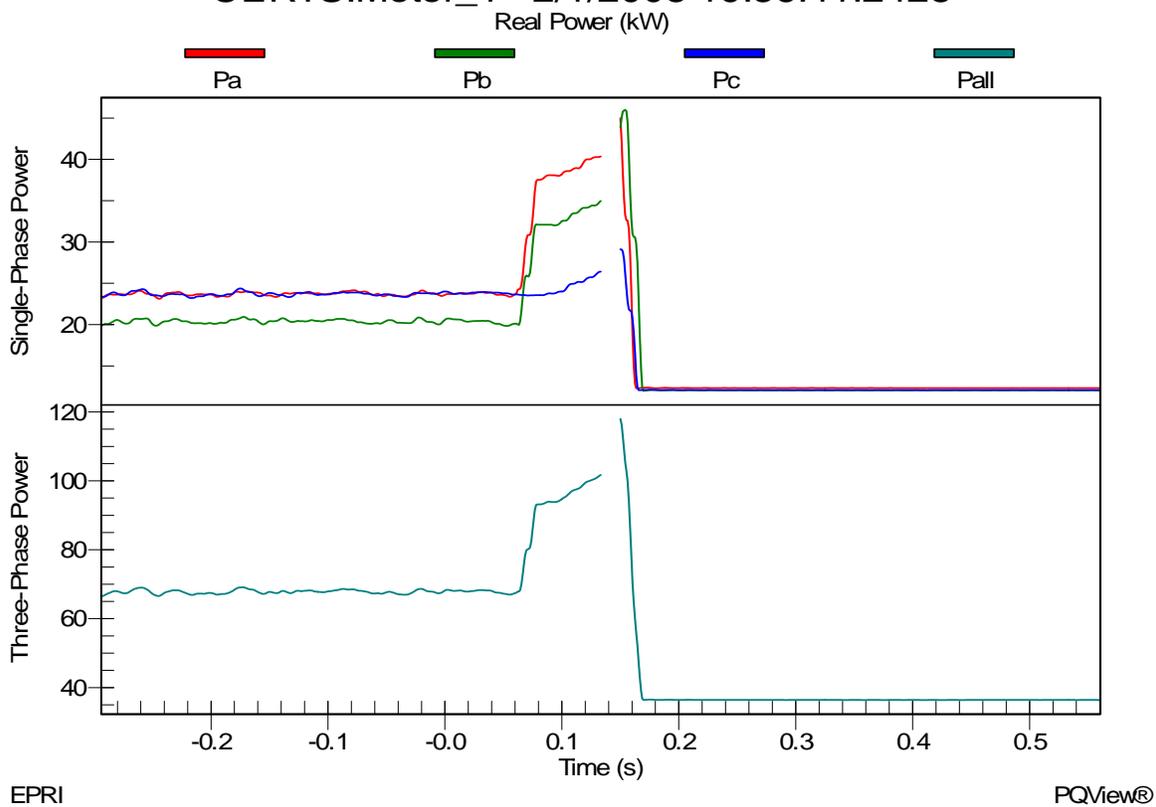
Figure 23a – Meter 1 power flow before/after the static switch opened, islanding the microgrid from the utility grid when a phase-to-phase fault was applied in Zone 4.

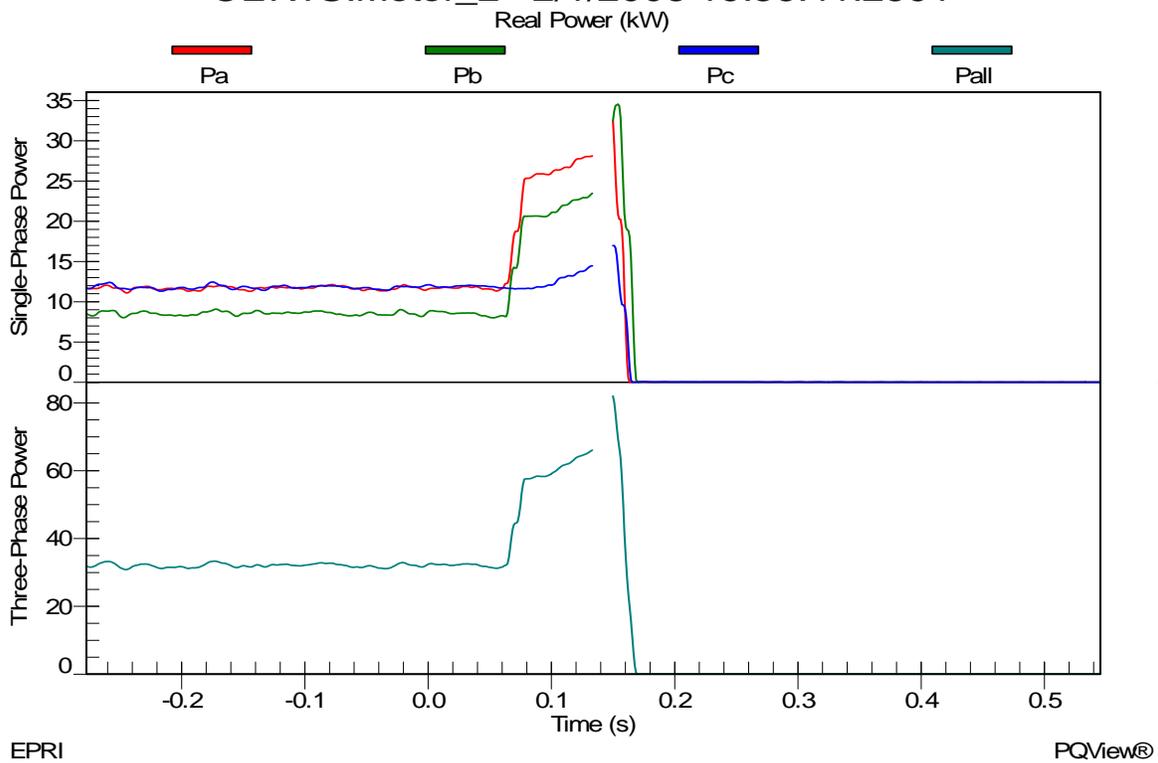
Figure 23b – Meter 2 power flow before/after the static switch opened, islanding the microgrid from the utility grid when a phase-to-phase fault was applied in Zone 4.

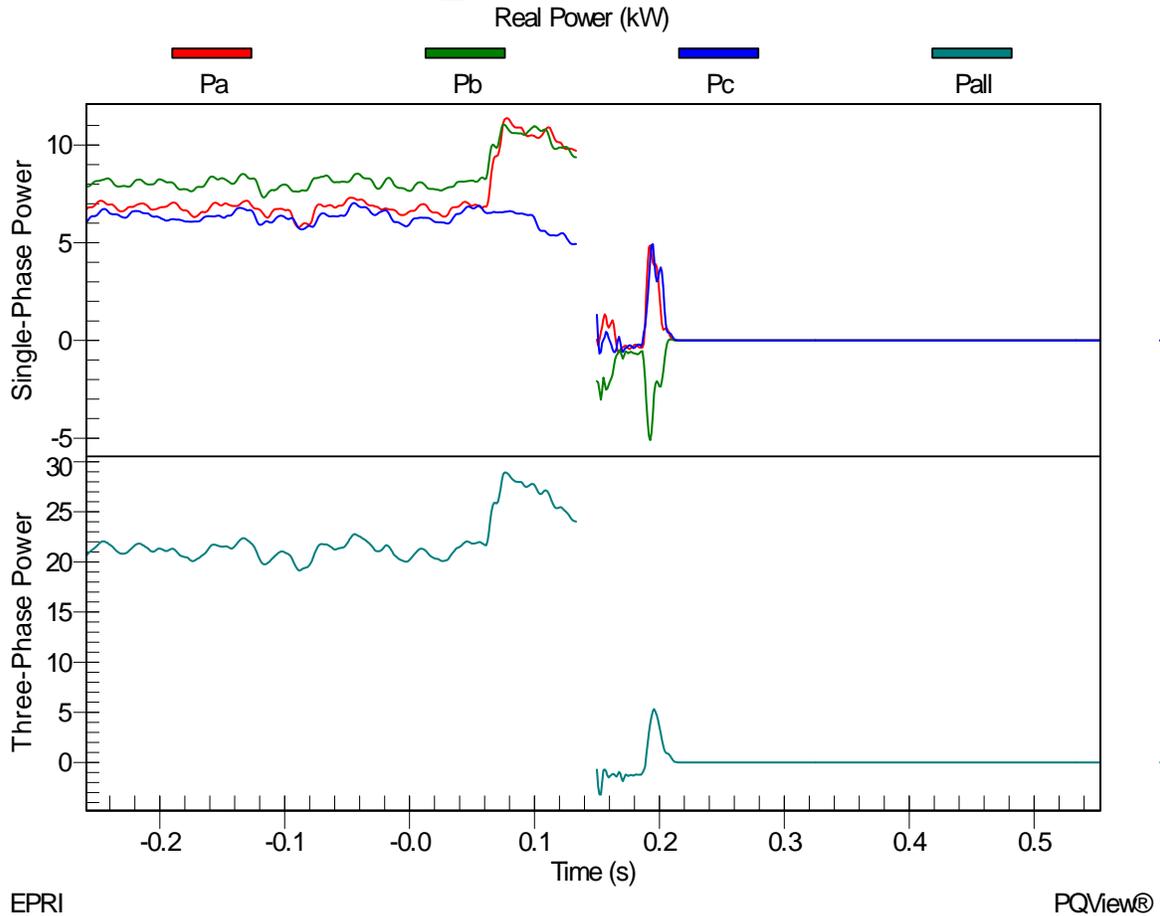
Figure 23d - Power produced by Gen-set A2 before/after the static switch opened when an A-phase to B-phase fault was applied in Zone 4.

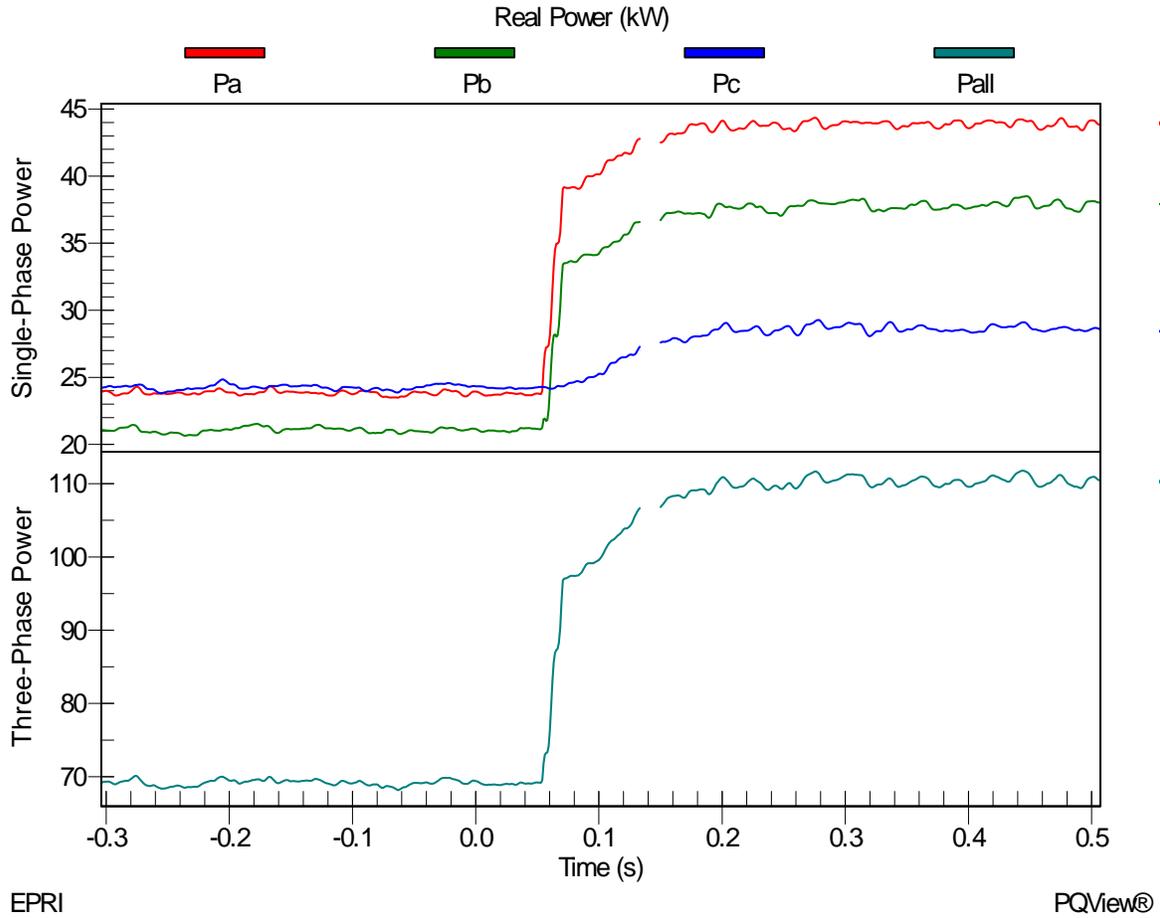
Figure 24a – Meter 1 power flow before/after the phase-to-phase fault was applied in Zone 2.

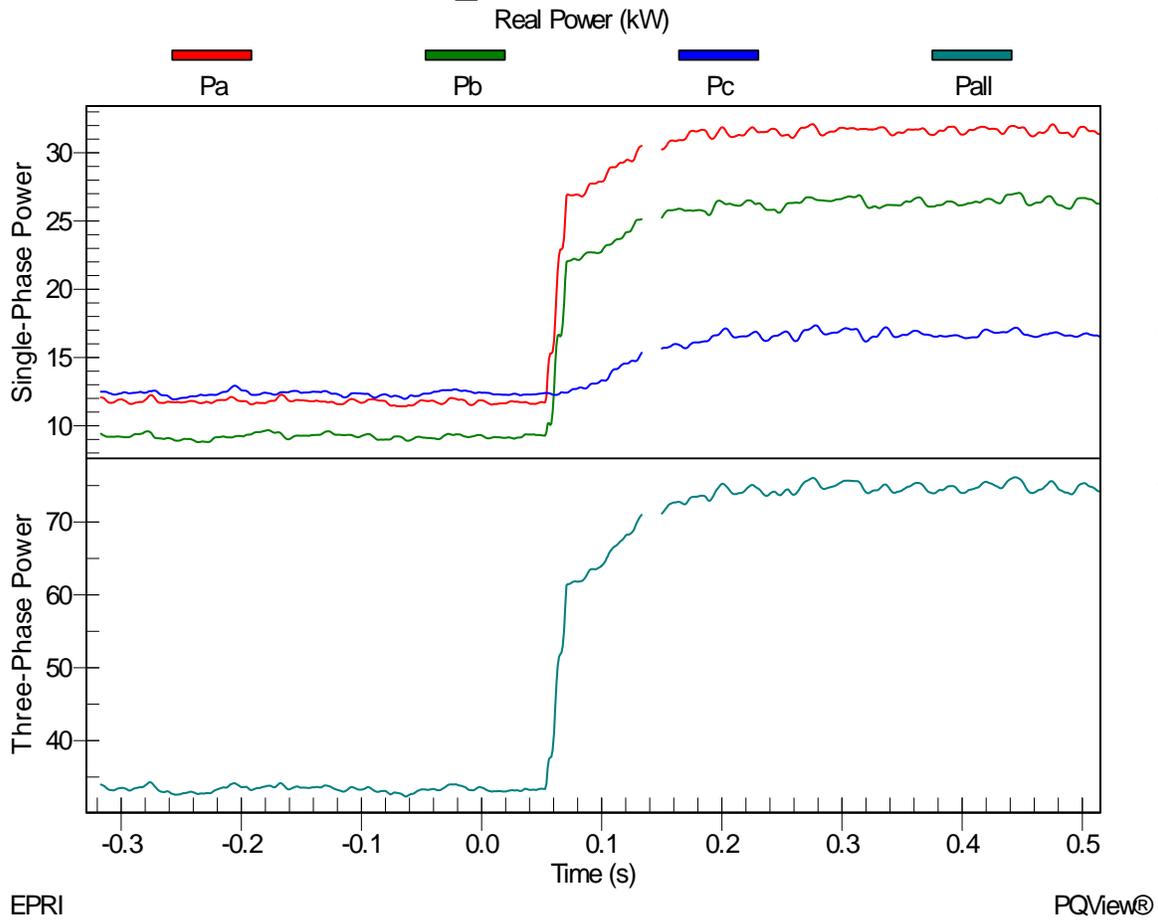
Figure 24b – Meter 2 power flow before/after the phase-to-phase fault was applied in Zone 2.

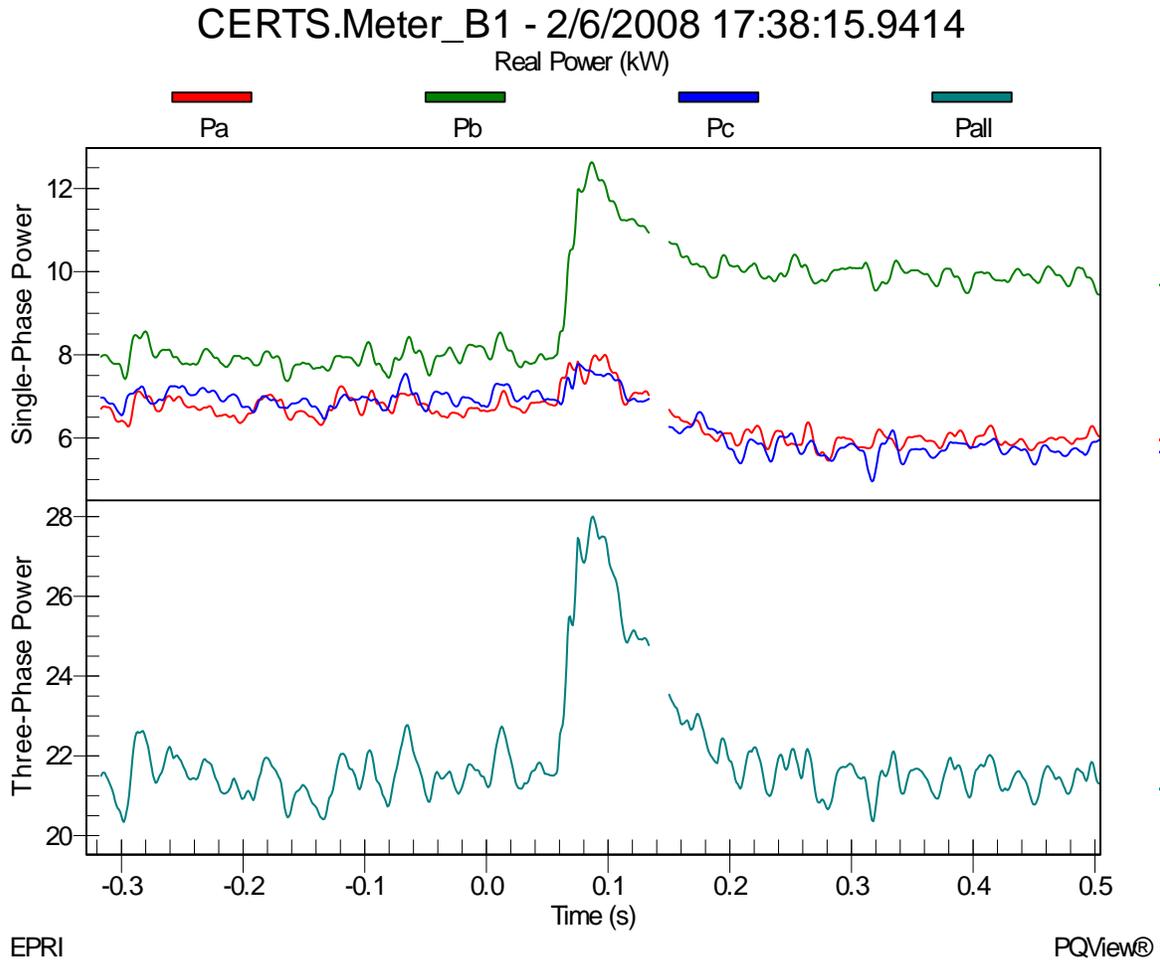
Figure 24d - Power produced by Gen-set B1 before/after an A-to-B phase-to-phase fault in Zone 2 is applied

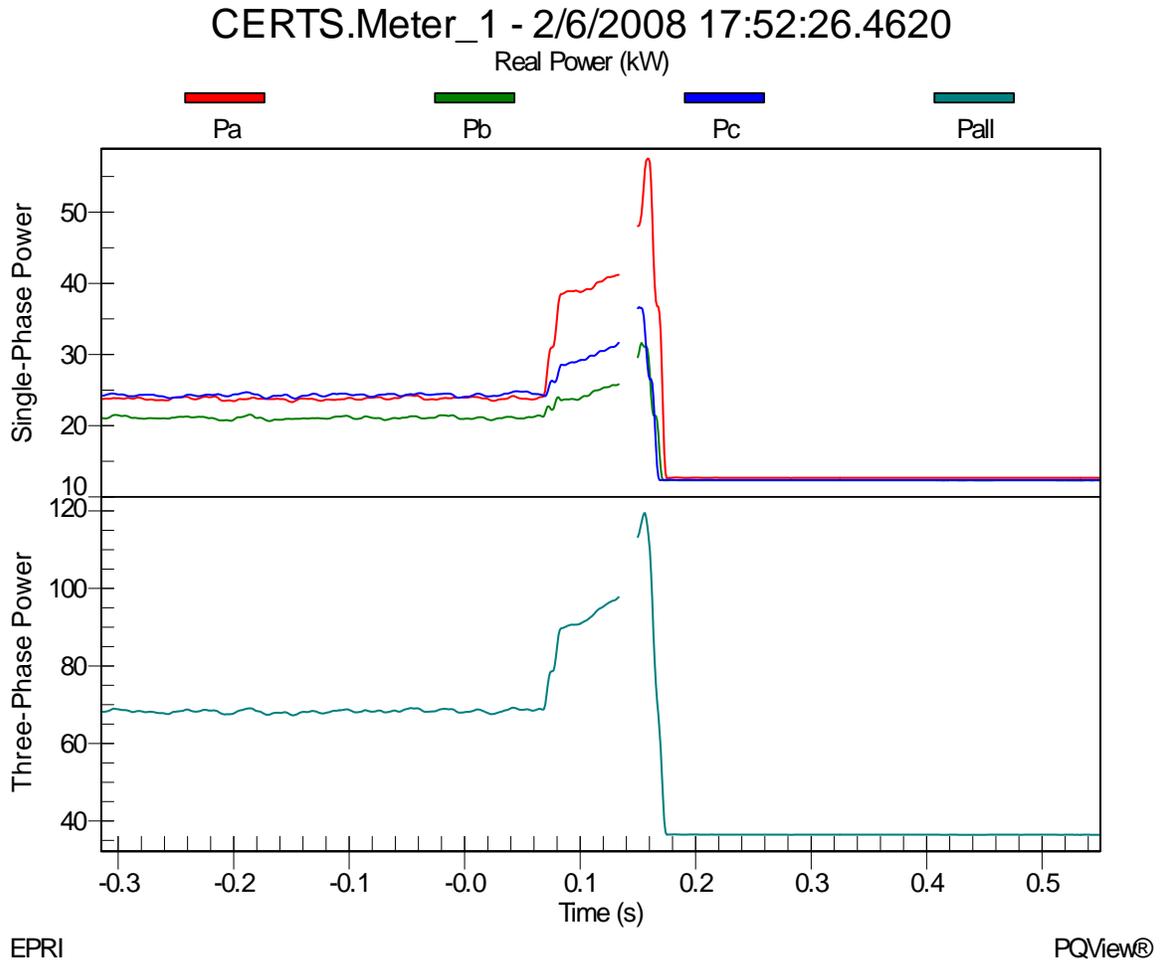
Figure 25a – Meter 1 power flow before/after the static switch opened, islanding the microgrid from the utility grid when a phase-to-phase fault was applied in Zone 5.

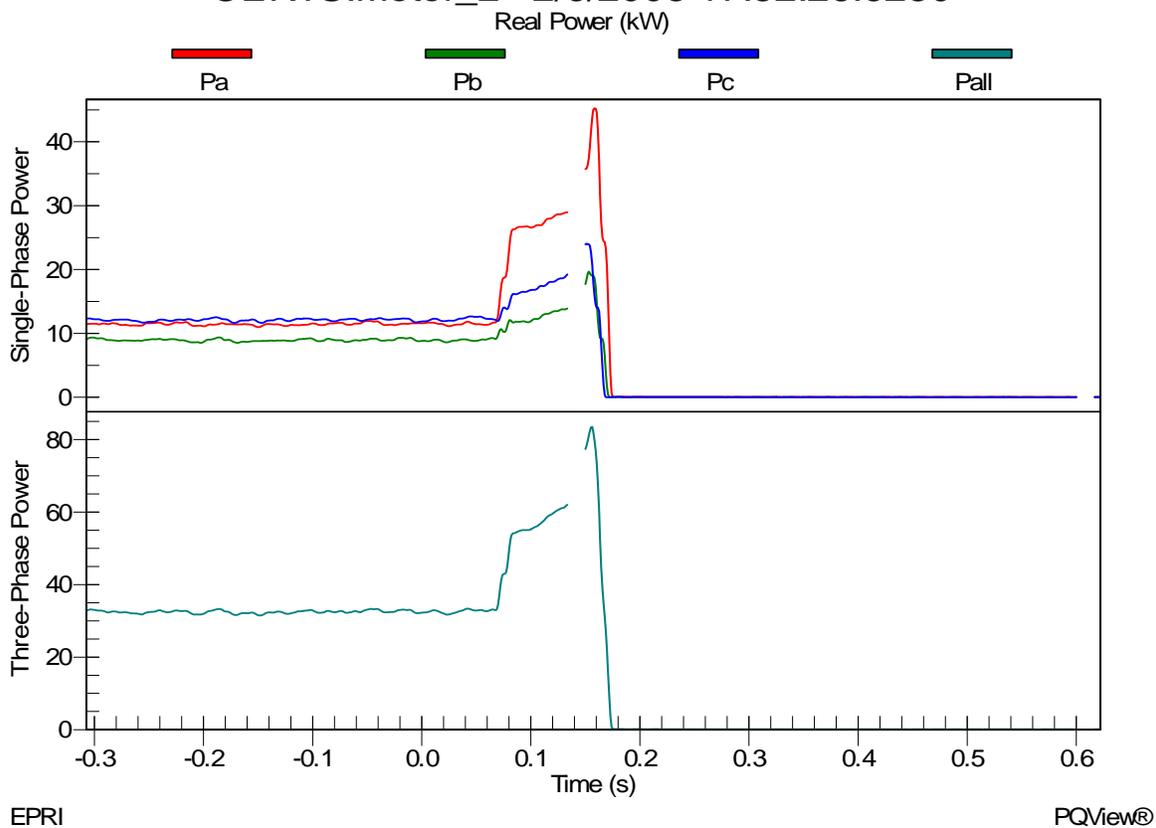
Figure 25b – Meter 2 power flow before/after the static switch opened, islanding the microgrid from the utility grid when a phase-to-phase fault was applied in Zone 5.

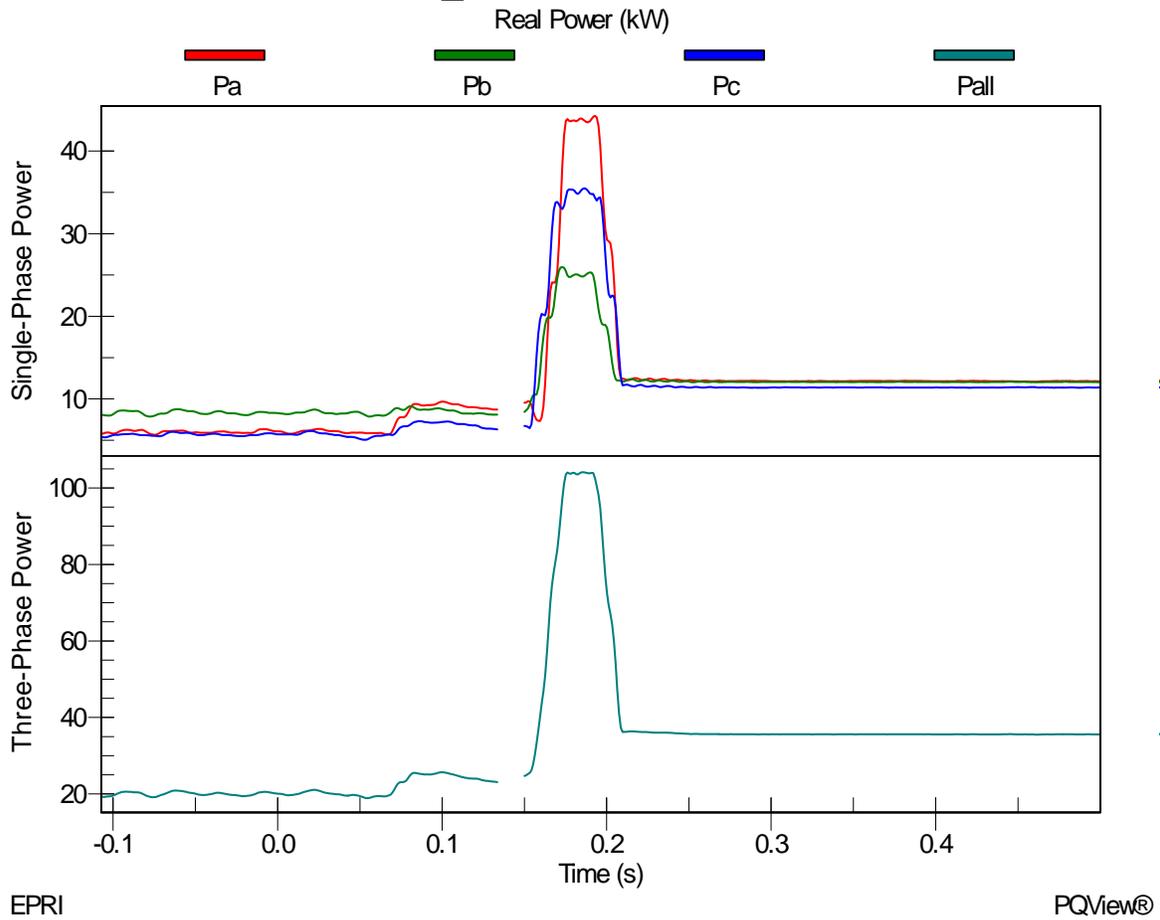
Figure 25c - Power produced by Gen-set A1 before/after the static switch opened from an A-phase to B-phase fault in Zone 5.

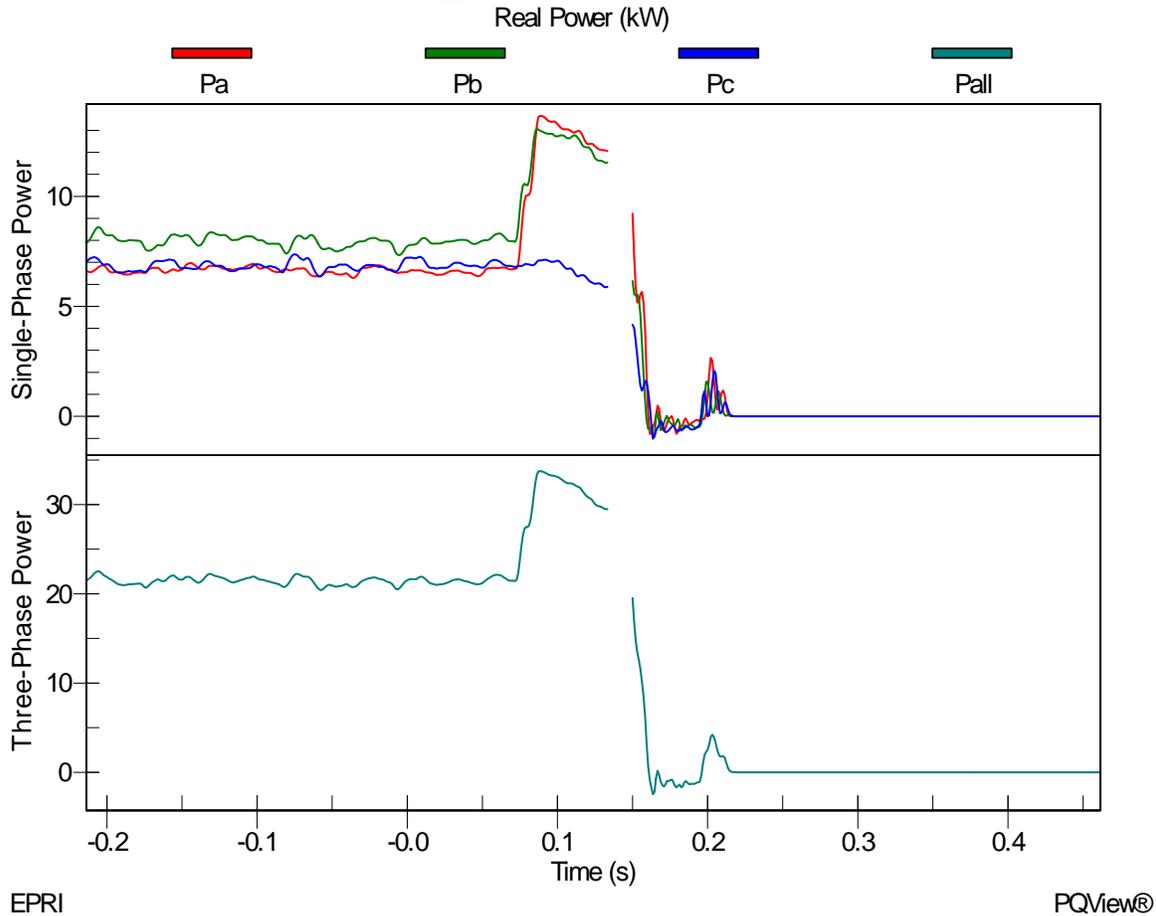
Figure 25d - Power produced by Gen-set B1 before/after the static switch opened from an A-phase to B-phase fault in Zone 5.

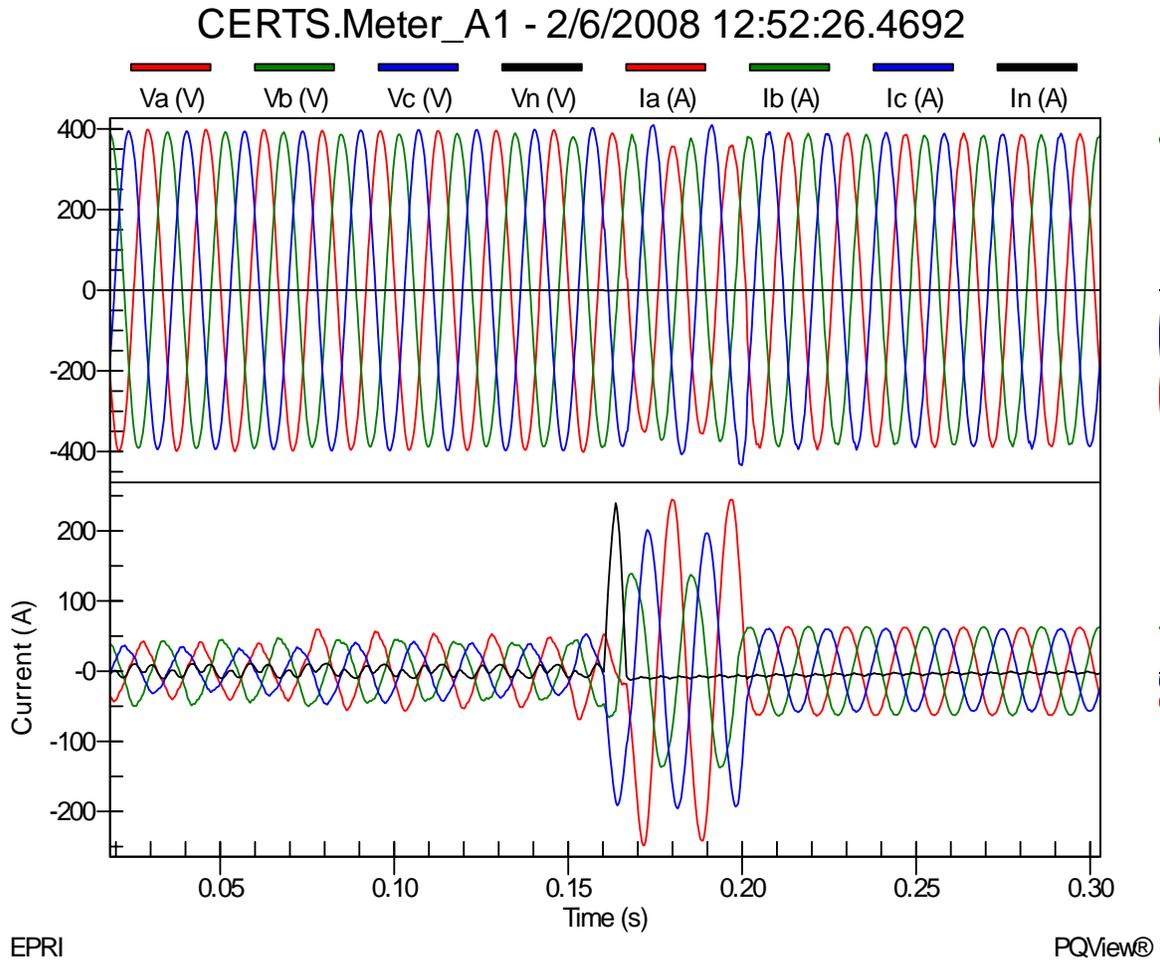
Figure 25h – Gen-set A1 current before/after a phase-to-phase fault was initiated in Zone 5.
